# SERVICE TIPS

| Reference | Subject | Date |
|---|---|---|
| ST-159 | Premature Belt Failures on ALS Built Tumblers | 1/17/2022 |
| Product | KT025, KT030, KTT30, KT035, KTT45, KT055 Tumblers after serial no. 1804 | |

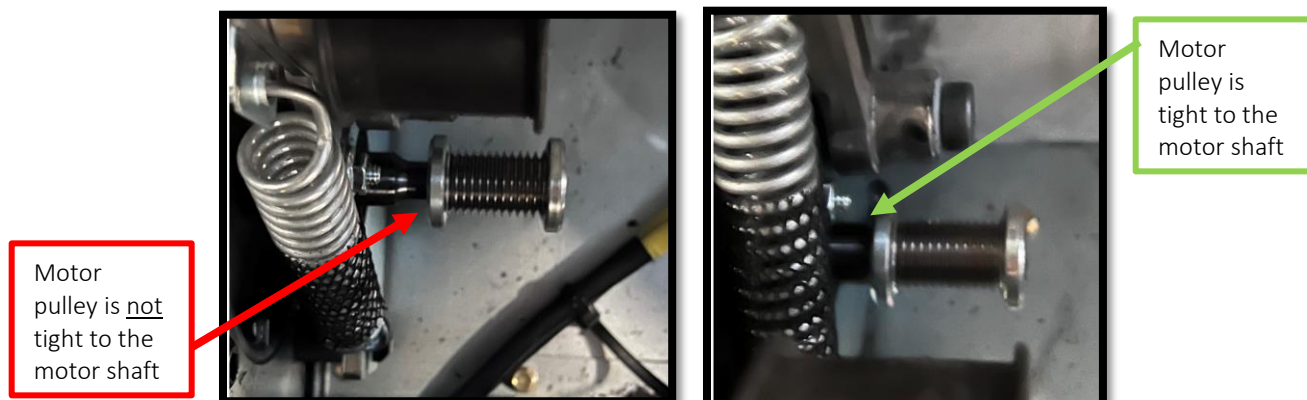
Premature belt failures in some KT025, KT030, KTT30, KT035, KTT45, and KT055 tumblers can be attributed with the misalignment of belt with either the idler arm or the motor pulley.

The motor pulley should rest tightly against the motor shaft's collar. The pulley should not move. Replace the motor if the pulley moves or is not tight to the collar of the shaft.

It is recommended when changing out the belt that you also change out the idler arm. The belt and idler arm are part of a kit listed below.
