# SERVICE TIPS

| Reference | Subject | Date |
|---|---|---|
| PB-131 | Door Lock Bitrons | 1/11/2021 |
| Product | All 55 Pound and Smaller Girbau Built Washers (Excluding EH055) | |

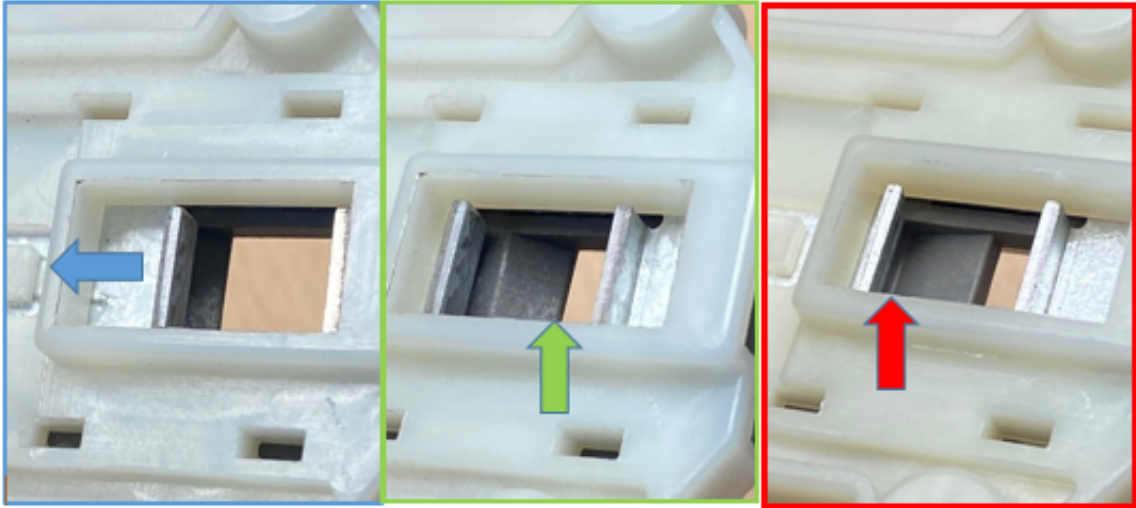
| Model Information | <div> </div> <div> <div> <b>Manually slide and hold metal locking tab to the locked position</b> </div> <div> <b>Inspect Gray Plastic Slope Profile. Slope down toward the opening is GOOD</b> </div> <div> <b>Inspect Gray Plastic Slope Profile. Slope down and away from opening is BAD</b> </div> </div> | | |

| Summary | <p>In 2020, Girbau Spain may have received incorrect door lock assemblies from our supplier, Bitron. The quantities, suspect parts, and dates are unknown. Incorrect Bitron door locks may have been introduced into production machines or service parts. This can cause issues with the door not locking, door not unlocking, and having to push at 10:00 on the door to open it.</p> <p>To inspect the Bitron, slide the locking tab to the side (blue arrow). Look closely at how the catch ramps. The GOOD Bitron (green) slopes towards the opening. The BAD Bitron slopes away from the opening.</p> <p>If you have a customer who has had repeated door lock issues on these units, please inspect the Bitron for the proper catch ramp slope. Please follow the typical warranty process.</p> | | |
